**Fractographic and Microstructural Analysis of  
Fatigue Specimens of A302 Grade B Steel  
Tested in Air at Room Temperature**

**G. GABETTA AND V. PROVENZANO**

September 28, 1979

Prepared for U.S. Nuclear Regulatory Commission

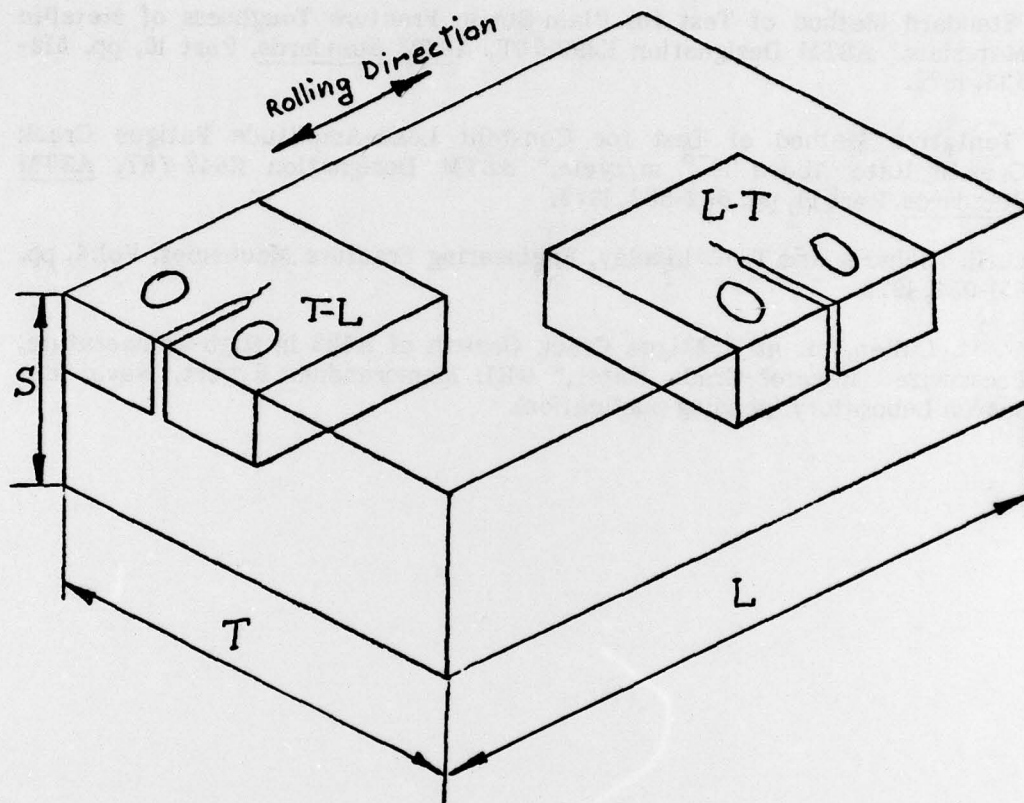
Fig. 1 Schematic diagram of fatigue specimen used for mechanical tests showing L and T directions.

The chemical composition of the A302-B steel plate is given in Table 1. Two sets of 1/2-in. compact tension specimens were tested. Each set consisted of two specimens, one cut in T-L and the other in the L-T orientation (Fig. 1).<sup>\*</sup> All fatigue tests were conducted in air at room temperature using a constant specimen deformation procedure; the applied load was sinusoidal with a frequency of 13.3 Hz. In this procedure, the value of  $\Delta K$  increases with crack length, even though the applied load is gradually decreased as the length increases. Additional details concerning the testing procedure are reported elsewhere [2].

<sup>\*</sup>The identification convention used is that suggested by ASTM E-399 (3) and is illustrated in Fig. 1.

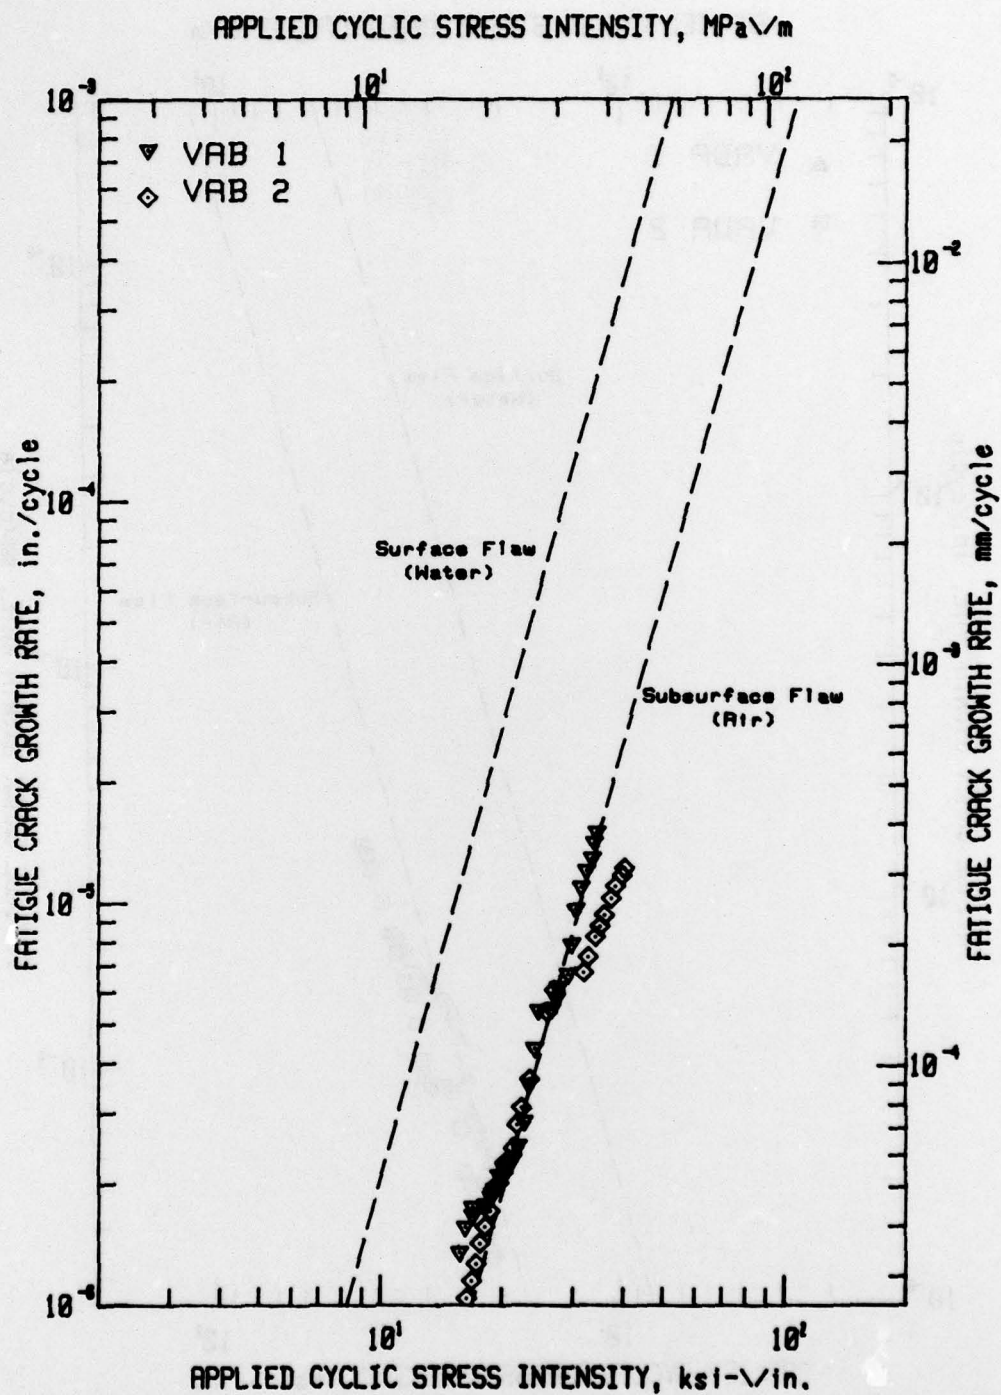
Fig. 3 Fatigue crack propagation data of A302-B ferritic steel tested in air at room temperature both for the T-L (VAB1) and L-T (VAB2) directions with the lower starting  $\Delta K$  value (16.5 MPa√m).

The FCP data obtained from the specimen tests are presented in Figs. 2 and 3. As shown by both figures, all of the crack growth data fell close to the ASME Section XI air line. The crack growth rates for the first set of specimens (Specimen VADA1, cut in the T-L direction, and Specimen VADA2, cut in the L-T direction) ran roughly parallel to each other for most of the  $\Delta K$  range, with the T-L specimen (VADA1) exhibiting the higher crack growth rate (Fig. 2). The crack growth rates for the second set of specimens (VAB1, cut in the T-L direction, and VAB2, cut in the L-T direction) were about equal for  $\Delta K$  values below 33 MPa $\sqrt{m}$  (30 ksi  $\sqrt{in.}$ ). Above this  $\Delta K$  value, the crack growth rate of the T-L specimen

(VAB1) was higher (Fig. 3). The difference in the crack growth behavior in the two sets of specimens was not large. It is interesting to point out however, that a lower starting  $\Delta K$  resulted in a higher growth rate (the starting  $\Delta K$  for VAB1 and VAB2 was  $16.5 \text{ MPa}\sqrt{\text{m}}$  while for VADA1 and VADA2 it was  $22 \text{ MPa}\sqrt{\text{m}}$ ). Since the basic objective of the mechanical tests was to investigate the effect of specimen orientation on the fatigue behavior the effect of starting  $\Delta K$  on FCP will not be critically evaluated in this report.

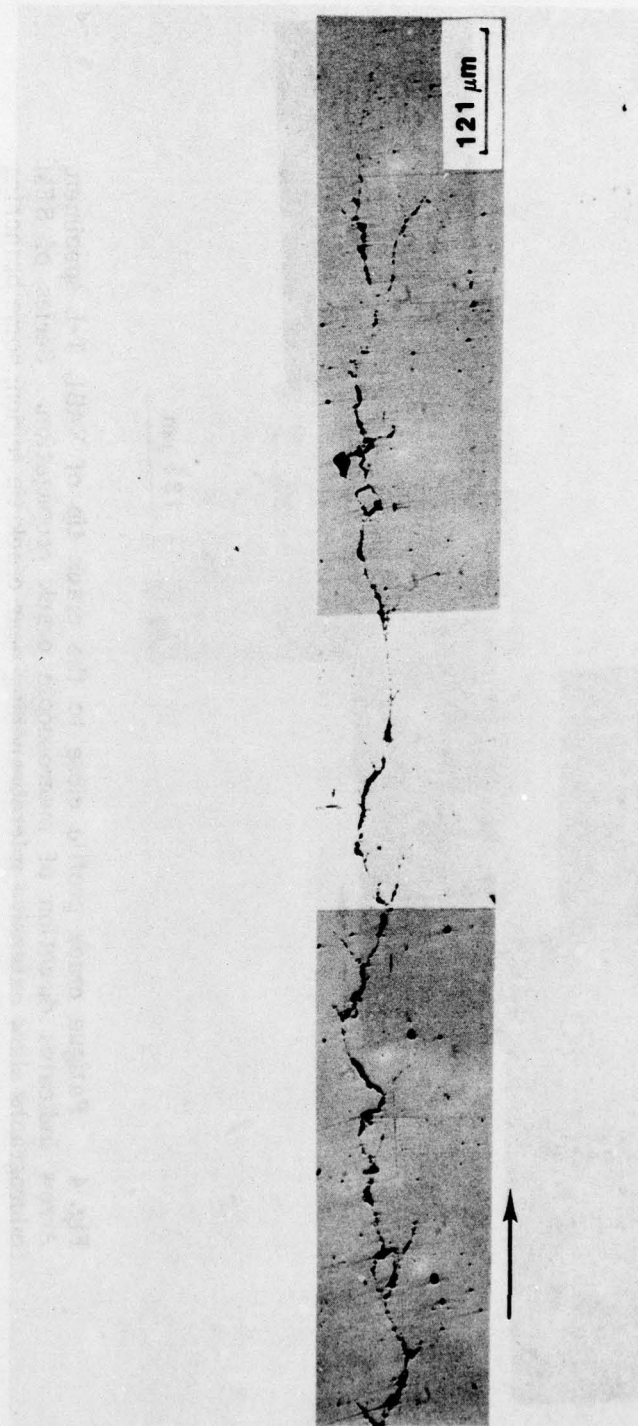
Fig 5 Fatigue crack profile close to the crack tip of VAB2, L-T specimen. Arrow show direction of macroscopic crack propagation. As in the case of the specimen cut in T-L direction, series of SEM micrographs show extensive micro-branching along the main crack path.

The relationships between the crack path and the microstructure are illustrated by the photomicrographs shown in Figs. 4 and 5. The photomicrographs in Fig. 4 refer to specimen VAB1 (T-L) while the micrographs presented in Fig. 5 refer to specimen VAB2 (L-T). The two crack profiles show that extensive crack branching is present in both specimens. The degree of crack branching, as indicated by the secondary cracks, becomes more pronounced in the high  $\Delta K$  region. In the region of high  $\Delta K$ , where the crack propagation rate is higher, the microcracks associated with crack branching are smaller in size and required a higher magnification to reveal their presence. The reduction in the average size of the microcracks in the high  $\Delta K$  regime did not appear to have affected the crack propagation behavior. Crack branching usually has the effect of slowing the crack propagation rate by distributing the stresses at the crack tip; this did not seem to have been the case in these two specimens.

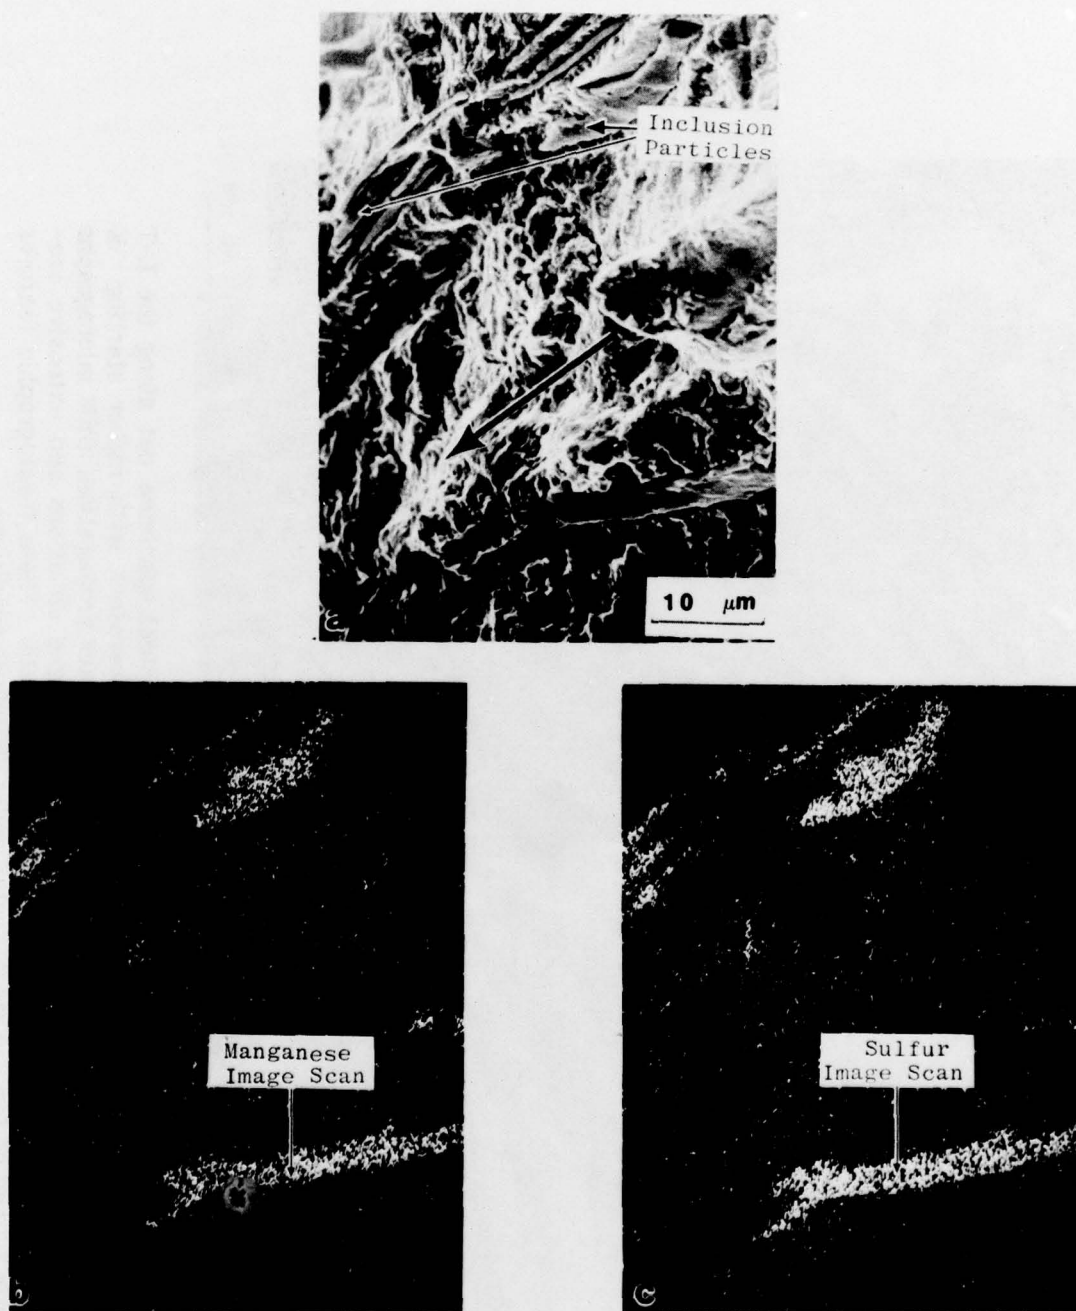
**Fig. 9** Fracture surface and corresponding energy dispersive X-ray point maps of A302-B ferritic steel specimen cut along T-L direction (VAB1). Arrow shows macroscopic crack propagation direction. SEM micrograph on top of the figure (micrograph a) clearly shows inclusion bands in the fracture surface that run parallel to the macroscopic crack propagation direction. Lower two micrographs are image scans obtained through energy dispersive X-ray microanalysis showing that inclusion bands are manganese (left) and sulfur (right) second-phase particles.

As observed above, the fracture surface of T-L specimen (VAB1) is characterized by a parallel texture when  $\Delta K$  exceeds a minimum value in the range of  $25\text{--}30 \text{ MPa}\sqrt{\text{m}}$ . This texture is thought to arise from inclusion bands that are present in the rolled material. These inclusions became elongated during the rolling procedure. To see if the parallel texture is indeed the result of the inclusion bands, the fracture surface was analyzed with an X-ray microanalyzer that is attached to an AMR 1000 scanning electron microscope. The results of the X-ray microanalysis are summarized in Fig. 9. The analysis confirms that the parallel features were manganese-sulfide inclusion bands.
